On the use of advanced measurement techniques for characterization of bond behavior in FRP-masonry components

ABSTRACT

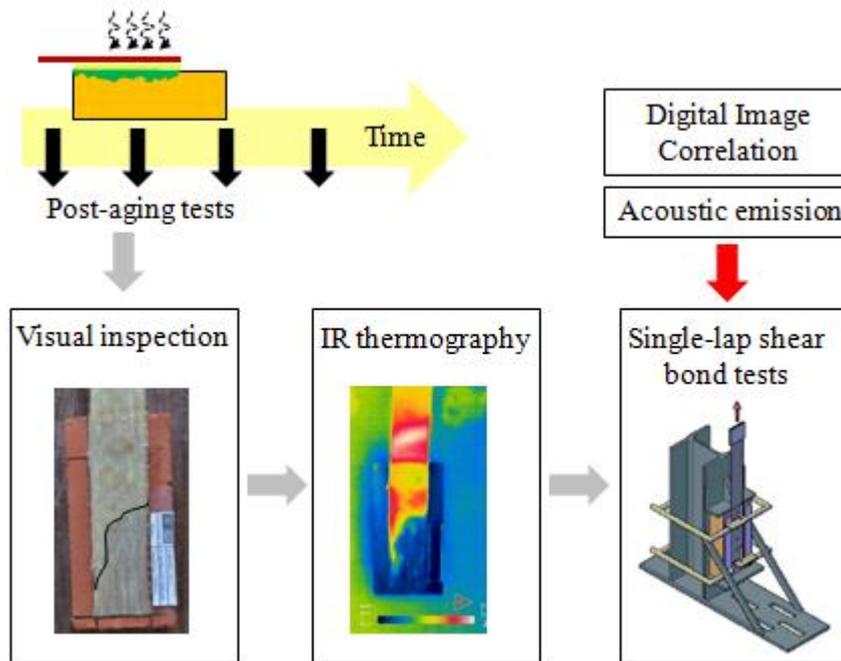
Figure 1 – Testing program.

The application of the above mentioned techniques in bond performance assessment during the debonding tests and after aging in environmental conditions is investigated in this section. For this reason, GFRP-strengthened brick specimens are prepared and exposed (after curing) to environmental conditions in a climatic chamber. Five specimens are taken from the climatic chamber after each 50 cycles of exposure for characterization of the bond degradation according to the protocol shown in Figure 1, (Ghiassi 2013a). Visual inspection is initially performed on the specimens for detection of any visible FRP delamination or color changes. Then, IR thermography test is performed on the specimens for detection of the environmentally induced FRP delaminations. The size of FRP delaminations are also quantitatively measured with the aim of advanced IR analysis algorithms. Single-lap shear bond tests are finally performed on the specimens for quantitatively characterization of bond degradation. The AE and DIC techniques are used during the debonding tests for characterization of the fracture progress and measurement of surface deformation. A review of the experimental test program and tests setup is given in this section.

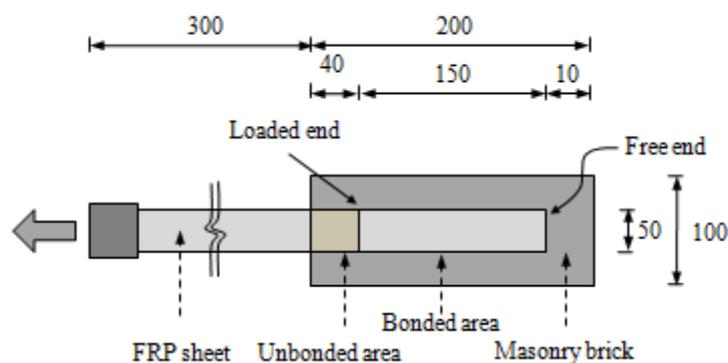
Figure 2 – Geometrical details of the GFRP-strengthened brick specimens (all units in mm).

The specimens consisted of single bricks strengthened with GFRP composites prepared following the wet lay-up procedure. Solid clay bricks with dimensions of 200×100×50 mm were used as substrate. The GFRP sheets with 50 mm width were applied on the bricks' surfaces with a bonded length of 150 mm leaving a 40 mm unbonded part near the loaded end. The bricks were dried in the oven before application of the GFRP sheets. Then, a two-part epoxy primer was applied to the brick's surface for preparation of the substrate surface. Finally, a two-part epoxy resin was used as the matrix for the composite material. The geometrical details of the specimens are shown in Figure 2.

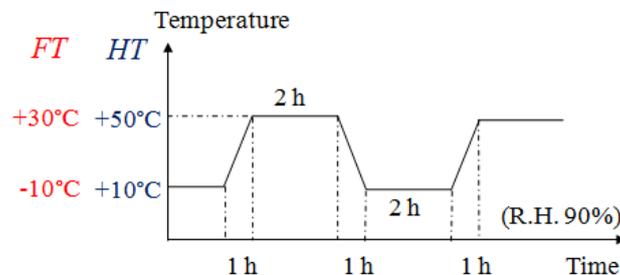
Figure 3 – Environmental exposures.

The specimens were exposed to two different accelerated hygrothermal conditions in a climatic chamber, see Figure 3. The aim was to investigate the applicability of IR thermography method in detection of environmental induced delaminations and interfacial defects.

In the first exposure, HT, the specimens were exposed to 6 hr temperature cycles from +10°C to +50°C and constant relative humidity of 90%. In each cycle, the temperature was kept constant at +10°C for 2 hr. The temperature was then increased to +50°C in 1 hr, followed by 2 hr constant temperature at +50°C. Finally, the temperature was decreased again to +10°C in 1 hr resulting in 6 hr cycles of exposure. In the second exposure, FT, the specimens were exposed to temperature cycles from -10°C to +30°C and, again, constant relative humidity of 90%. The specimens were subjected to a total of 200 cycles in each exposure condition. The specimens were inspected visually and tested with IR thermography technique after each fifty cycles of exposure to investigate the applicability of the test method in obtaining the environmental induced interfacial defects and delaminations.

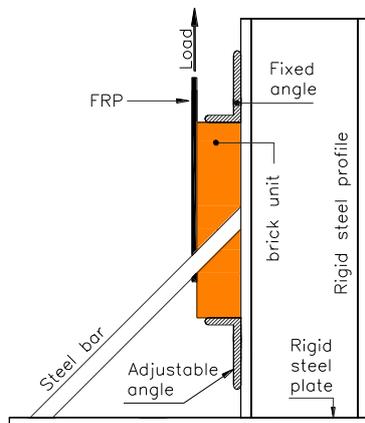
Figure 4 –Schematic of the delamination tests setup.

Single-lap shear bond tests were performed using a closed-loop servo-controlled testing machine with maximum load capacity of 50 kN. A rigid supporting steel frame was used to support the specimens appropriately and avoid misalignments in the load application, see Figure 4. The specimens were placed on the steel frame and firmly clamped. The specimens were pulled monotonically with a speed rate of 5 $\mu\text{m}/\text{sec}$ under displacement control conditions with reference to the LVDT placed at the loaded end of the FRP composite. The resulting load was measured by means of a load cell.

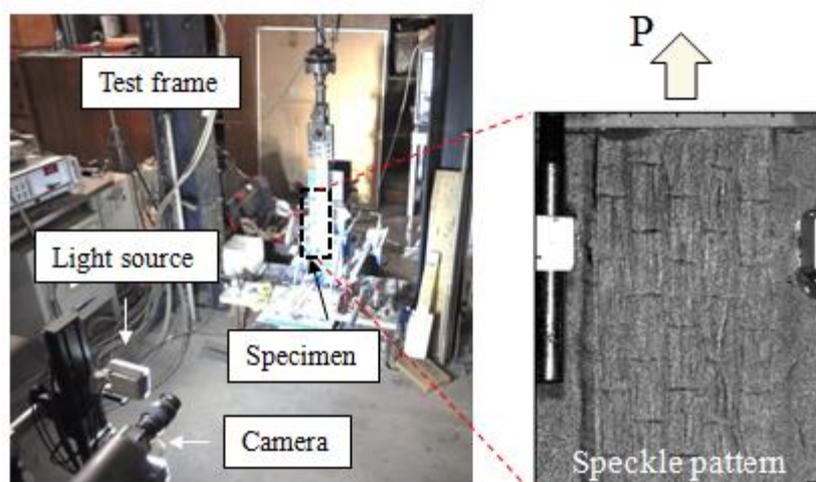
Figure 5 – Digital image correlation test setup

For application of the DIC technique in fracture characterization, the specimens were prepared by applying a speckle pattern on the Region of Interest (ROI), produced by applying a thin coating of white matt followed by a spread distribution of black dots using spray paint. The ARAMIS DIC-2D (2009) software by GOM was used in this work. The measurement system was equipped with an 8-bit Baumer Optronic FWX20 camera coupled with a Nikon AF Micro-Nikkor 200mm $f/4\text{D}$ IF-ED lens. The optical system was positioned facing the surface of the specimens during the delamination tests, see Figure 5. A laser pointer was used to guarantee the correct alignment of the camera with regards to the specimen. The working distance (defined between the target surface and the support of the cameras) was set about 1.8 m leading to a conversion factor of $0.037 \text{ mm} \cdot \text{pixel}^{-1}$. The aperture of the lens was completely open (minimum depth of field) in order to focus the image on the specimen's surface. The lens aperture was then closed to $f/11$ in order to improve the depth of field during the testing. The shutter time was set to 5 ms. The light source was finally adjusted in order to guarantee an even illumination of the target surface and to avoid over-exposition. The typical resolution of the measurements was in the range of 10^{-2} mm and 0.02-0.04 % for displacement and strain evaluation, respectively.

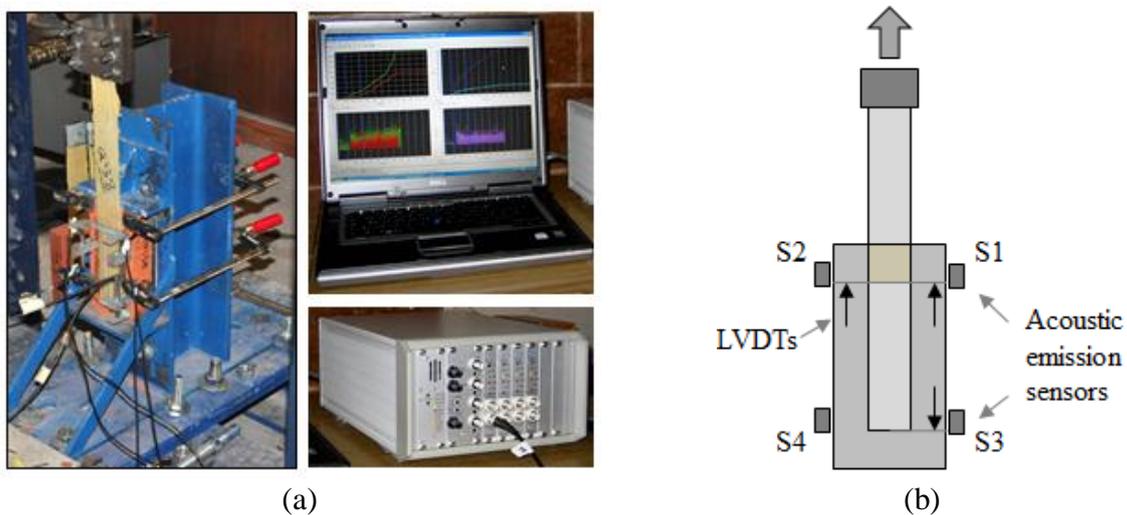
Figure 6 – Acoustic emission tests: (a) test setup; (b) test instrumentation.

Acoustic emissions were monitored, during the delamination tests, using a 4-channel Vallen AMSY-5 system with 150-500 kHz operation frequency and 5 MHz sampling rate. Four 150 kHz resonance sensors were attached to opposite sides of the bricks by means of hot melt glue, see Figure 6. The preamplifier gain was set to 34 dB with a fixed threshold level of 40 dB and pencil lead breaks were used for system calibration. To calculate the AE energy, the AE signal is squared and integrated and the energy unit (eu) is given by $1\text{eu} = 10^{-14}\text{V}^2\text{s}$.

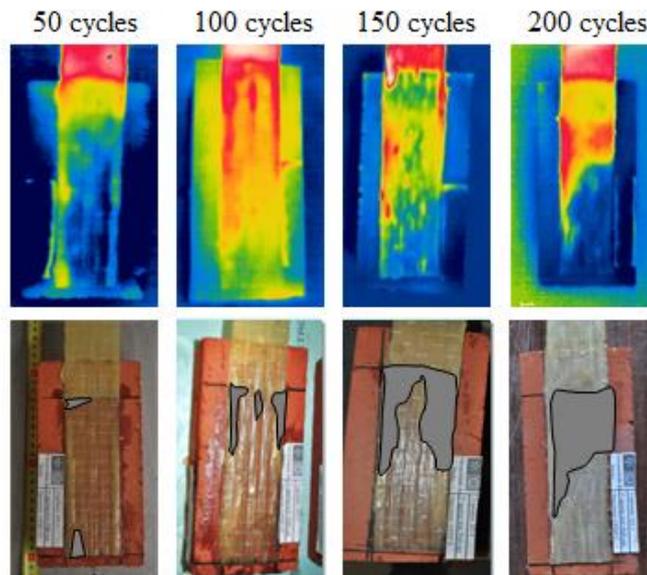
Figure 7 – Qualitative assessment of delaminated areas after different periods of exposure to HT conditions, using IR tomography.

As expected, FRP delamination is observed in some specimens after exposure to hygrothermal conditions. In general, relatively large FRP delaminations were observed in the specimens exposed to HT conditions. On the contrary, the specimens exposed to FT conditions have very small delamination. As an example, the corresponding thermal images and detected FRP delaminated areas, from IR thermography tests, for the specimens exposed to HT conditions are presented in Figure 7. It can be observed that the FRP delamination is progressively increased with the exposure time.

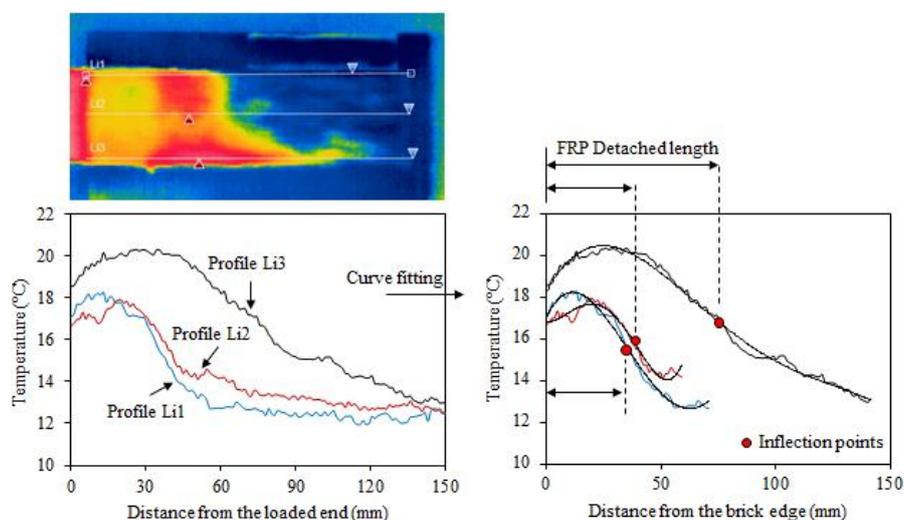
Figure 8 – Temperature profiles and quantitative assessment of delaminated areas in a specimen exposed to 200 cycles of HT exposure.

Once the delamination is localized, the captured thermograms are analyzed according to the two-point inflection method to quantify the FRP delaminated areas. For this reason, the temperature profiles are obtained along the bonded length at longitudinal sections (trying to obtain the edge lines and the center line of the delamination area), see e.g. Figure 8. Then, the temperature profiles near the detached areas are fitted with a 4th order polynomial curve (Lai et al. 2013; Ghiassi et al. 2014a). The inflection point of the estimated curve is selected as the boundary of the FRP delaminated area.

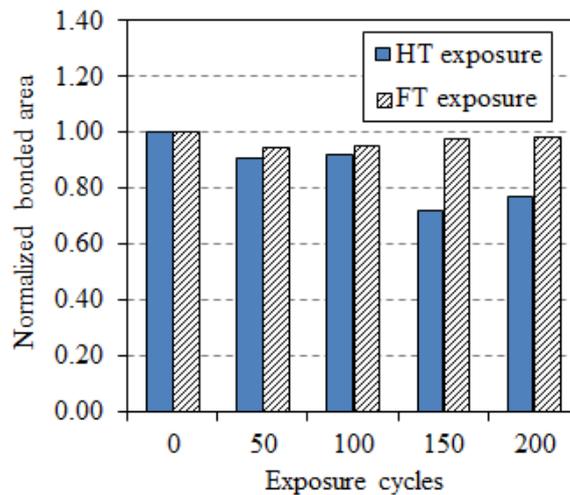
Figure 9 – Reduction of the bonded area with exposure cycles.

The observed delaminations are evaluated quantitatively in all the specimens according to the described methodology. Figure 9 presents the results as the average of five specimens in terms of the remaining bonded area normalized to the initial bonded area. It can be observed that the delamination in the specimens exposed to HT exposure is relatively large (23% reduction of bonded area after 200 cycles). Meanwhile, the reduction in the bonded area in the specimens exposed to FT conditions is very limited (2% after 200 cycles). Moreover, a sudden increase in delamination rate can be observed after 100 cycles of exposure to HT conditions, followed by some stabilization.

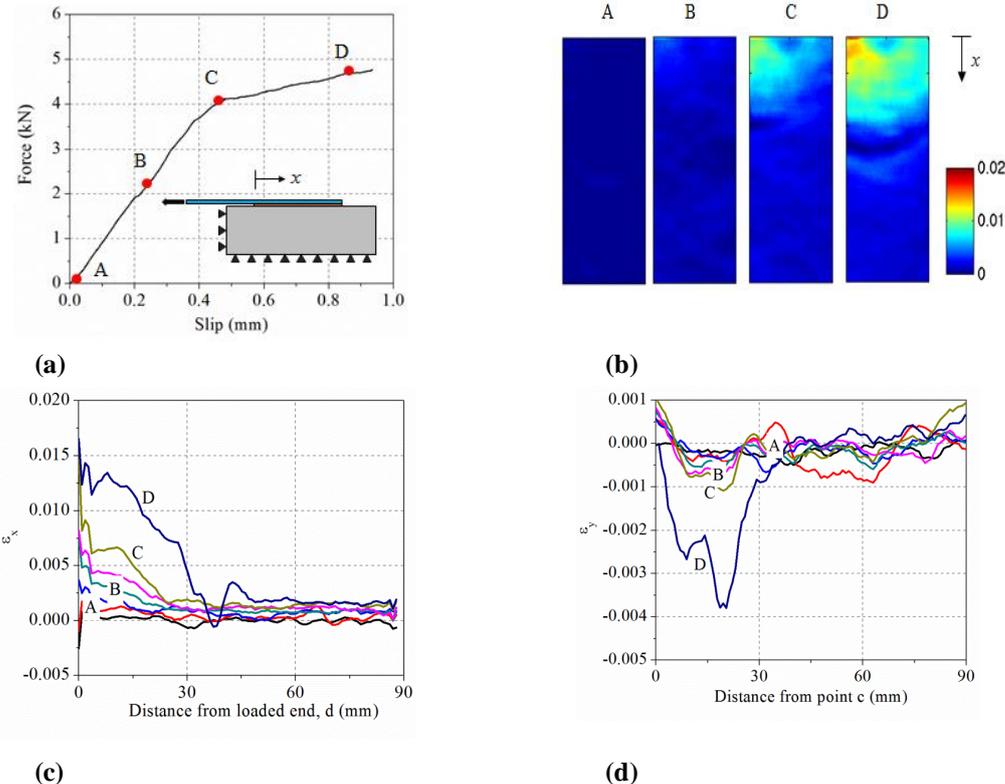
Figure 10 – (a) Typical experimental force-slip curve; (b) full-field longitudinal strains; (c) longitudinal strains along the middle of FRP; (d) transversal strains along FRP edge.

The typical force-slip response of the specimens obtained from delamination tests is shown in Figure 10(a). The distribution and evolution of strains with load increment along the bonded length, determined from the DIC measurements, is also presented, see Figure 10(b). The strain contours are corresponding to the distribution of the longitudinal strain on the FRP surface at different load levels, denoted by A ($0.1P_u$), B ($0.5P_u$), C ($0.8P_u$), and D (P_u). It can be observed that the DIC provides the possibility of monitoring the evolution of strains during the delamination tests. A light unsymmetrical distribution of strains can be observed at point D, Figure 10(b), which can be attributed to the unsymmetrical loading of the specimens during the test or inhomogeneous bond characteristics along the width of the selected specimen. It should be noted that detection of the above mentioned unsymmetrical strain distribution is an advantage of using full-field measurement techniques in comparison to conventional use of strain gauges. Having the full-field distribution of strains, the strain profiles can be extracted at any load step and location. As an example, the longitudinal and

transverse strains profiles obtained in the middle of FRP are shown in Figure 10 (c, d). The significant transversal strains appear near the loaded end at high load levels being an evidence of the three-dimensional nature of the debonding phenomenon. It can be observed that the strain values increase suddenly moving forward from point C to D which is due to the initiation of debonding and crack propagation along the FRP bonded length.

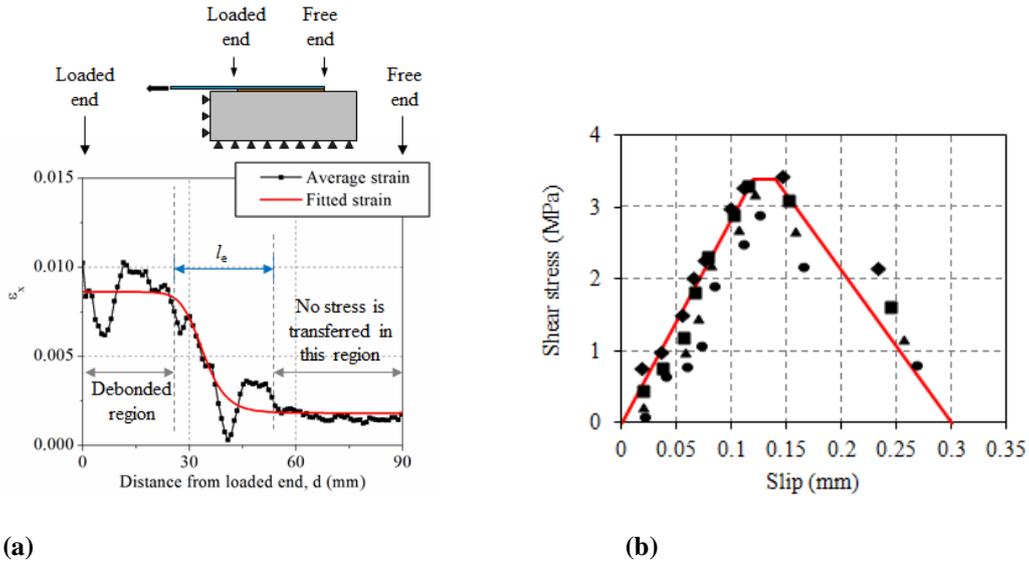
Figure 11 – (a) Average longitudinal strain along FRP middle section and the effective bond length l_e ; (b) bond-slip law.

The longitudinal strain profiles are then approximated with a nonlinear expression by performing a regression analysis, see Figure 11(a). It can be seen that the bonded area consists of three main regions. The FRP is fully debonded from the substrate near the loaded end. This is followed by a stress transfer zone, and after that no stress is transferred to the substrate. The length of the stress transfer zone, about 30 mm in this case (average of three tests), is the effective bond length. The longitudinal strain profiles can also be used for obtaining the bond-slip laws which are used as the input for numerical modeling approaches (Ghiassi et al. 2013b).

where $d\varepsilon_f / dx$ is the gradient of FRP strain along the sheet length, E_f is the FRP elastic modulus, and t_f is the FRP thickness. Having the stress and slip distribution along the bonded length at each load level, the bond-slip law of the specimens is extracted and presented in Figure 11(b). It seems that the bond-slip curve follow a tri-linear trend with a plastic branch in the middle.

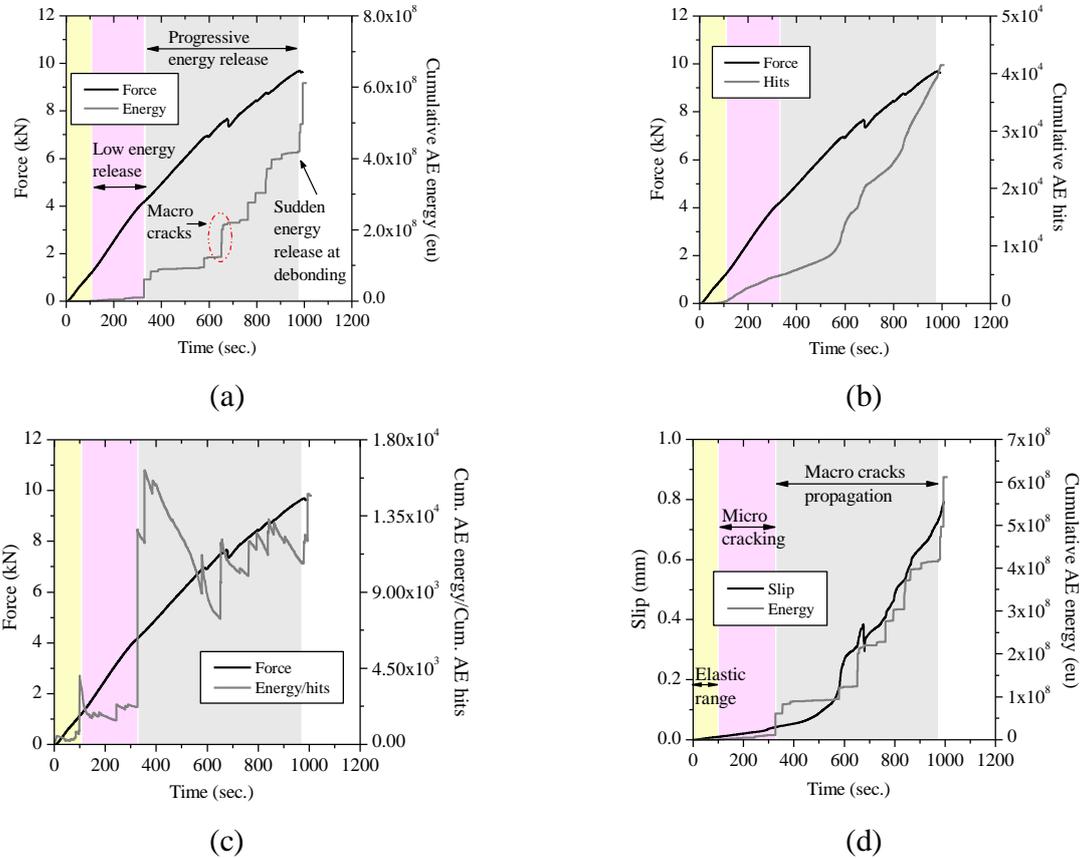
Figure 12 – Typical AE results in reference specimens: (a) force-cumulative AE energy; (b) force-cumulative AE hits; (c) force-energy/hits, E/h ; (d) slip-cumulative AE energy.

Typical AE results obtained from the debonding tests on GFRP-strengthened brick specimens are shown in Figure 12. The results are presented for a reference specimen with mixed cohesive/adhesive failure mode, in terms of cumulative AE energy and hits together with the force and slip development during the tests. The cumulative AE energy to hit ratio, called E/h hereafter, is also investigated and the results are presented.

Generally, the debonding phenomenon can be divided into three main regions: elastic range, micro-cracking range, macro-cracking and fracture range. In the elastic range, the system deforms without any crack generation and AE activities. The displacement measured at this stage is small being due to the elastic deformation of the FRP composite. As the applied force increases, micro-cracks appear in the interfacial region and they can be distinguished by initiation of AE activity with low emitted energies, e.g. after 100 sec of the test in Figure 12 (a, b). Since the fracture energy release due to the formation of micro-cracks is relatively small, low values of AE energies are expected in this region, see Figure 12 (a). The rate of detected AE hits is higher than the AE energy rate at this stage, resulting in a descending E/h , which indicates the formation of micro-cracks, see Figure 12 (c). As the debonding progresses, macro-cracks are formed and propagated along the interface with higher fracture energy being released. Therefore, higher AE energy is detected in this region. The cumulative AE energy increases with a stepwise pattern in which each sudden jump of energy can be correlated to a sudden fracture energy release and can thus be attributed to macro-fracture events, see Figure 12 (a, d). A sudden release of a high amount of AE energy can also be observed at the moment of full debonding, coinciding with the end of the test. The E/h ratio, Figure 12 (c), shows that each stage of the progressive debonding starts with a high rate of energy release (observed as a sudden jump in the E/h curve) and continues with a

descending rate until the end of each stage. The sudden jumps in E/h curve, in macro-fracture range, are due to the formation of macro-cracks with high energy release. Figure 12 (d) shows a clear correlation between slip increment and cumulative AE energy. This correlation can be used for predicting the FRP slip or debonding fracture energy in FRP-strengthened masonry elements.

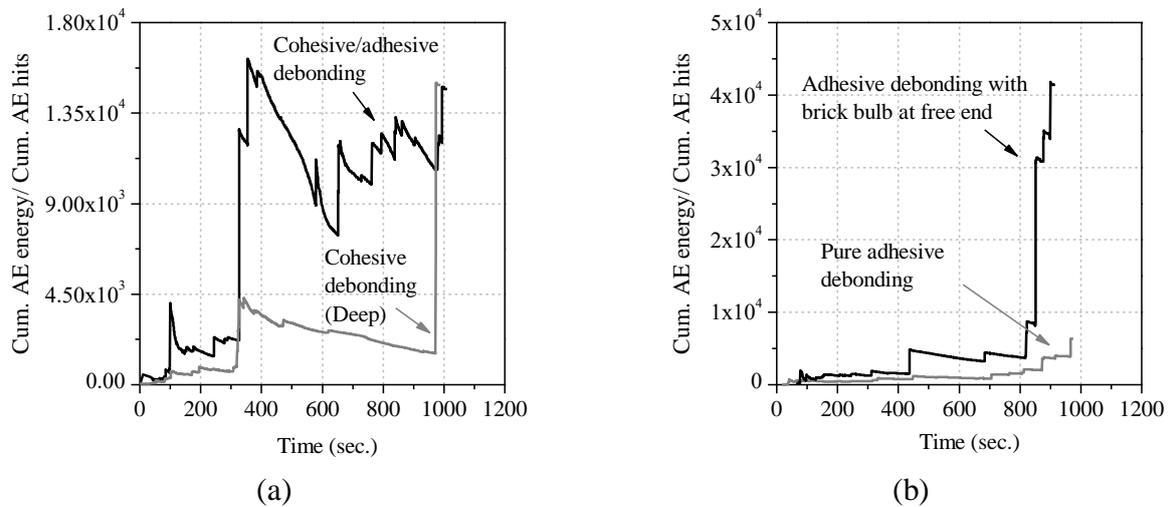
Figure 13 – Comparison of different failure modes: (a) cohesive; (b) adhesive.

The effect of failure mode on the AE outputs is investigated in Figure 13. A clear distinction is found between AE outputs of specimens with different failure modes. It can be observed that in the specimen with cohesive debonding the AE energy remains relatively low throughout the test, accompanied by a sudden and large amount of AE energy release and increase of E/h ratio when the debonding occurs at the end of the test, see Figure 13 (a). The observed behavior confirms the brittle and sudden nature of the cohesive debonding. Fewer peaks are observed in the E/h curve compared to the specimen with cohesive/adhesive debonding. At the end, a macro-crack with a high amount of energy release has suddenly occurred, leading to the complete debonding of the FRP. On the contrary, in the specimen with cohesive/adhesive failure a progressive release of energy is observed during the test. The high rate of energy detection shows the high number of active cracks and progressive failure during the tests. In the specimen with adhesive debonding mode, Figure 13 (b), increasing detection of AE energy is observed until the complete debonding. However, the magnitude of the detected energy is much lower than the ones detected in the specimens with cohesive failure mode. This large difference is due to the different nature and fracture properties of brick and FRP/brick interface. The specimen with adhesive failure combined with formation of a brick bulb at the free end shows a similar AE energy emission similar to the specimen with pure adhesive failure. However, a large amount of energy is released in this specimen before debonding due to the brick bulb fracture at the free end.
